Hunters Point Naval Shipyard BCT Meeting

Parcel B (Excluding IR Sites 7 & 18) Remedial Action Update

December 6, 2012

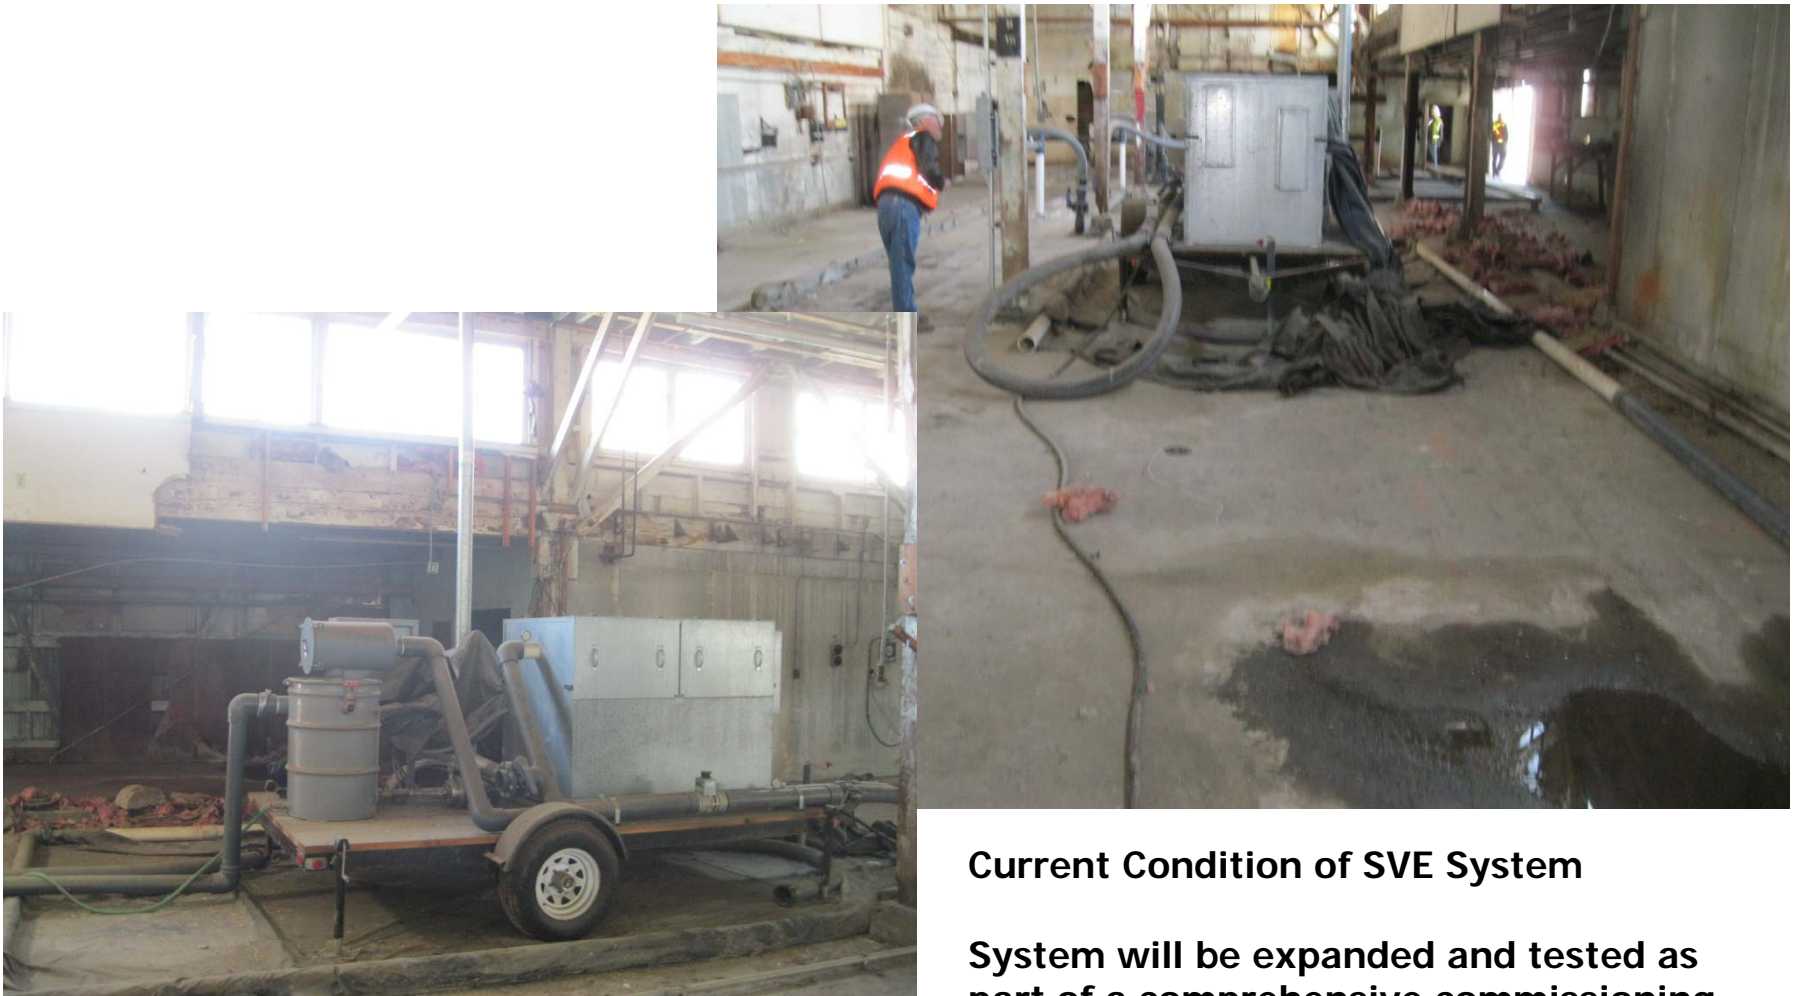
RA Overview - SVE System Photos

Current Condition of SVE System

System will be expanded and tested as part of a comprehensive commissioning process

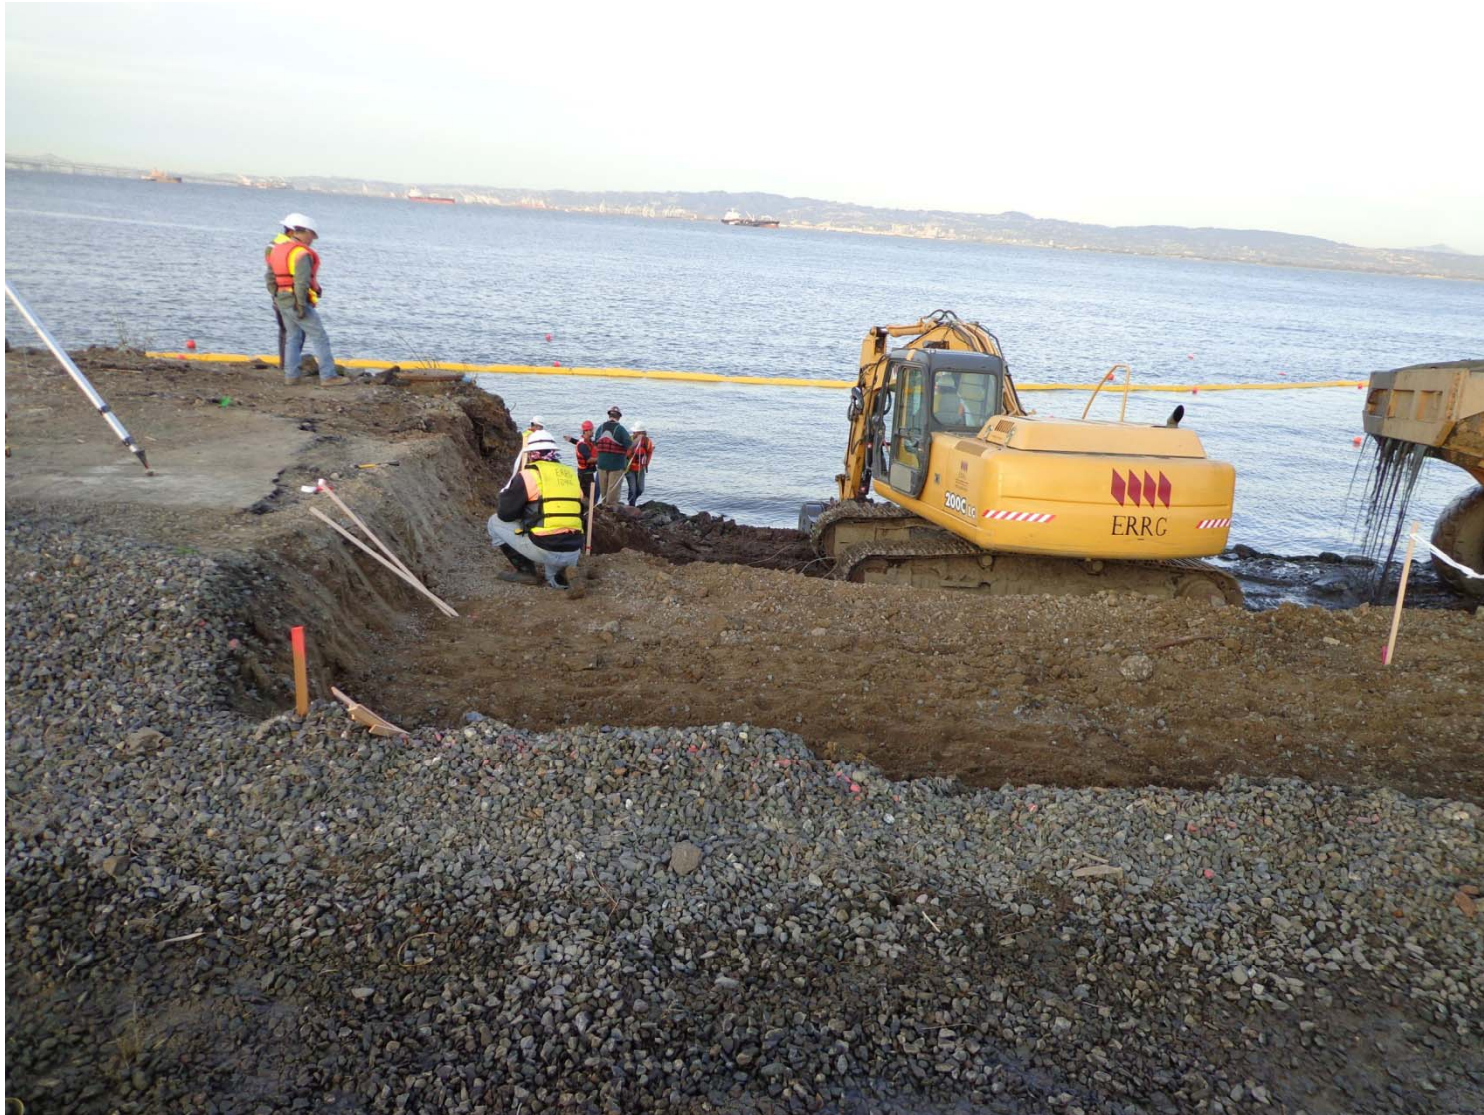
Revetment Excavation Between STA 1300+00 and STA 1320+00

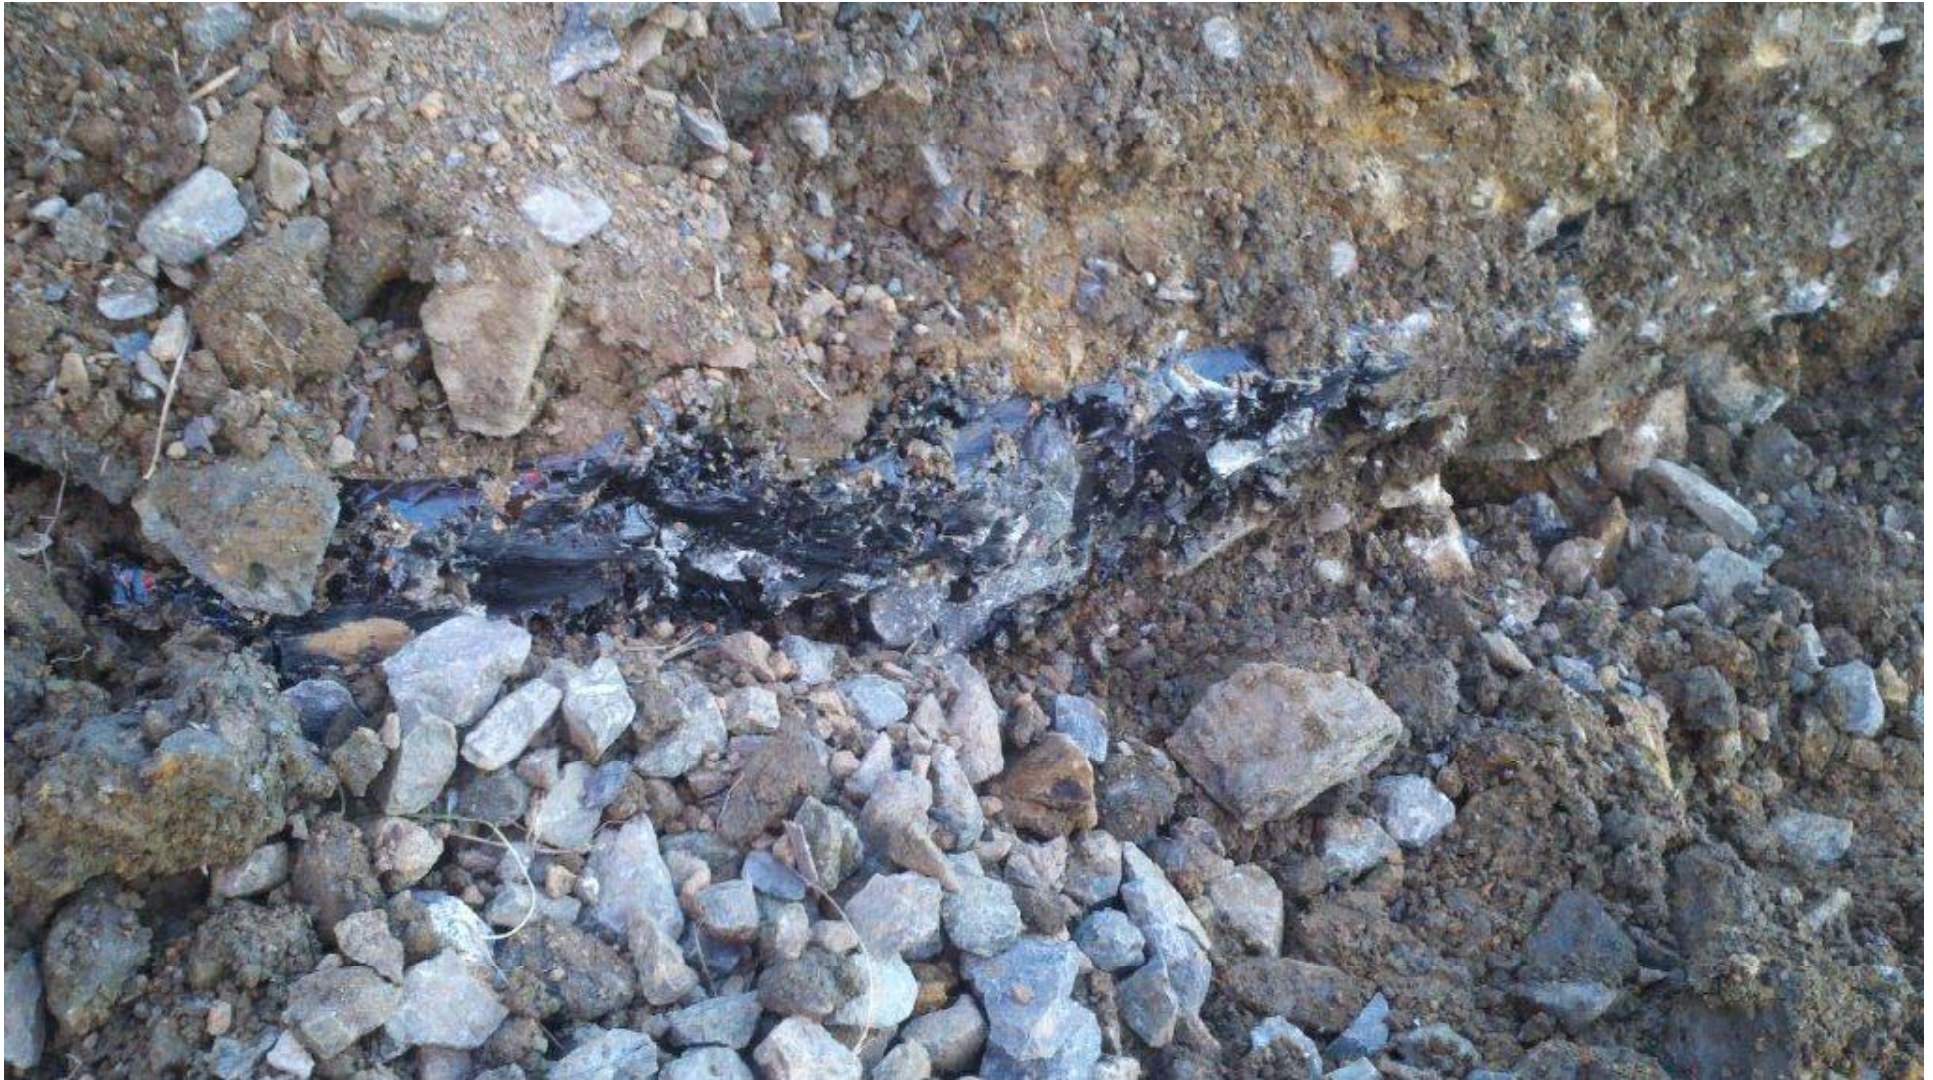
Vitrified Petroleum Lens

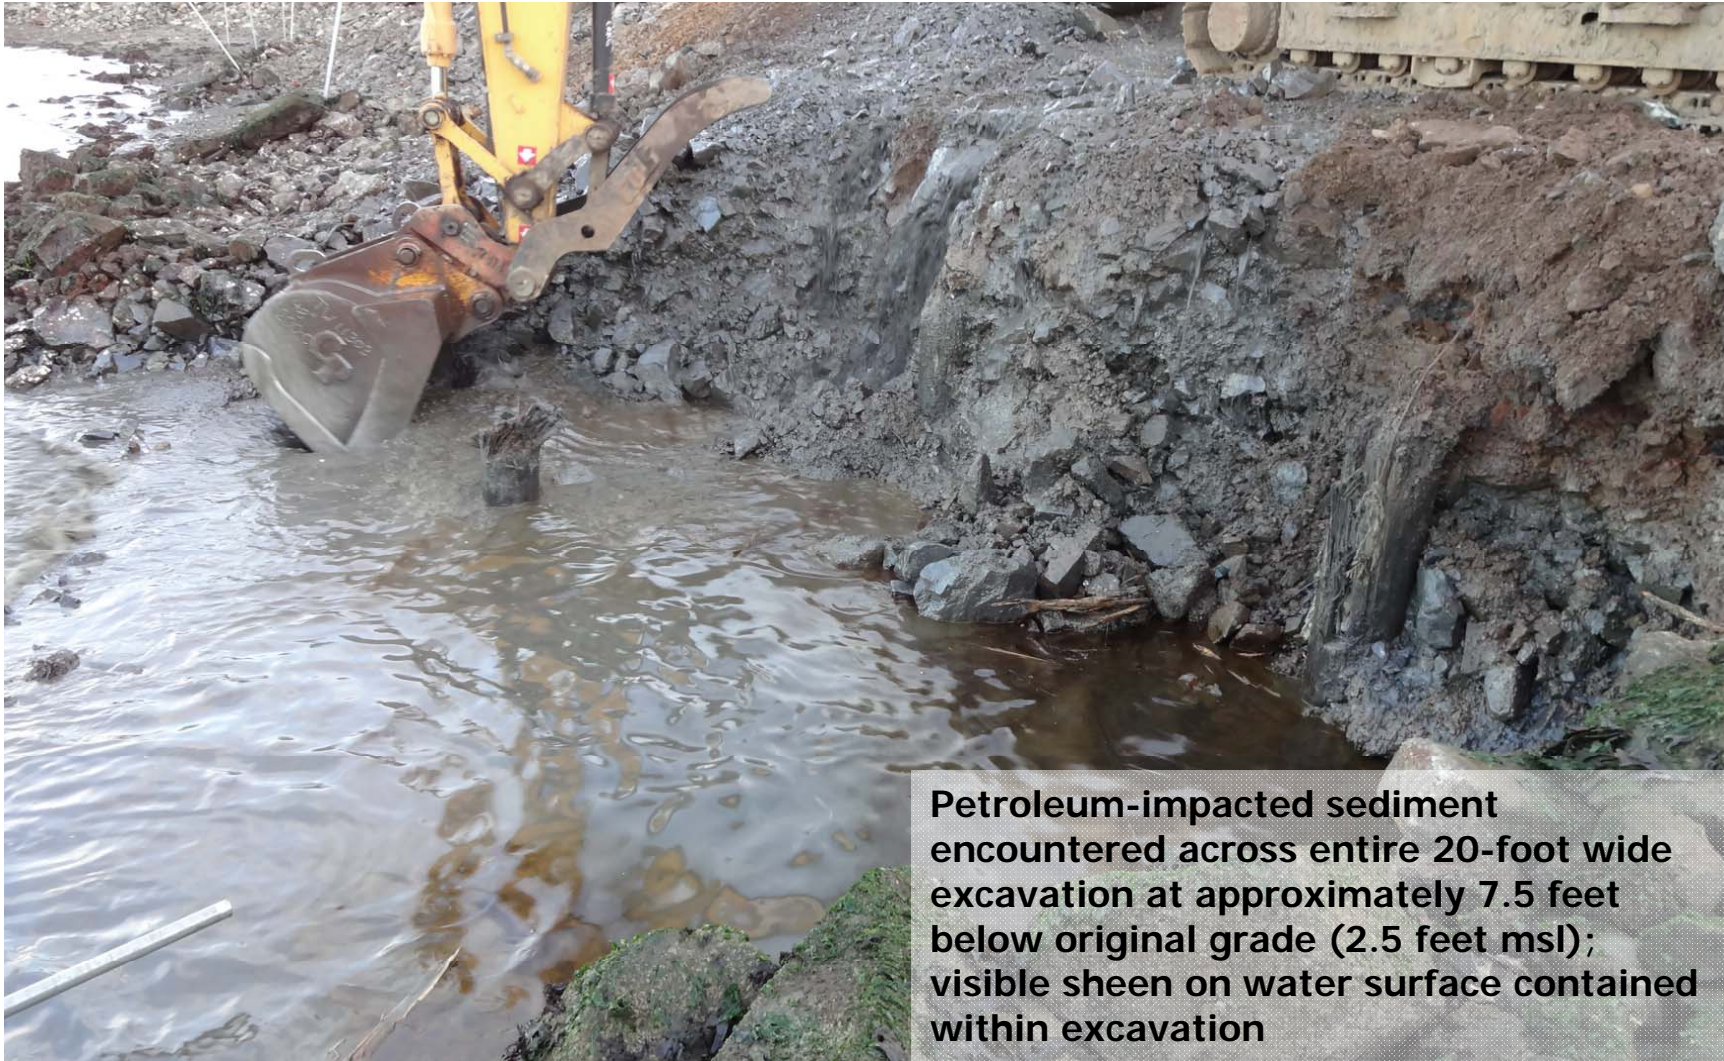
- Petroleum Contamination in Shoreline Sediment (*cont.*)
 - While excavating the revetment slope at lower elevations, petroleum hydrocarbon material (product and contaminated soil) with a strong diesel odor was discovered
 - The contamination appeared to be present between -1.4 feet MSL and 2.5 feet MSL
 - Contaminated soil and free product was visible in the excavated soil and along the entire 20-foot wide excavation
 - An oily sheen was observed on the water trapped within the excavation and petroleum product leaching from the sidewall of the excavation at the water level elevation in the excavation

Petroleum-Impacted Sediment Discovered

Petroleum-impacted sediment encountered across entire 20-foot wide excavation at approximately 7.5 feet below original grade (2.5 feet msl); visible sheen on water surface contained within excavation

- A hydrocarbon boom was deployed at the toe of the excavation to prevent the leached product (sheen) from migrating out into the SF Bay
 - Contaminated sediment loosened during the excavation process was removed and relocated to a bermed, plastic-lined stockpile area, and the pile was covered with plastic

- The excavation sidewall was lined with geotextile material and filter rock was installed over the entire footprint of the excavation to stabilize the geotextile

- 8 samples of the contaminated stockpiled soil were collected and sent to an off-site laboratory for rush TPH analysis
 - Hydrocarbon-absorbent boom was deployed the next day along the entire length of the turbidity curtain as a precautionary measure

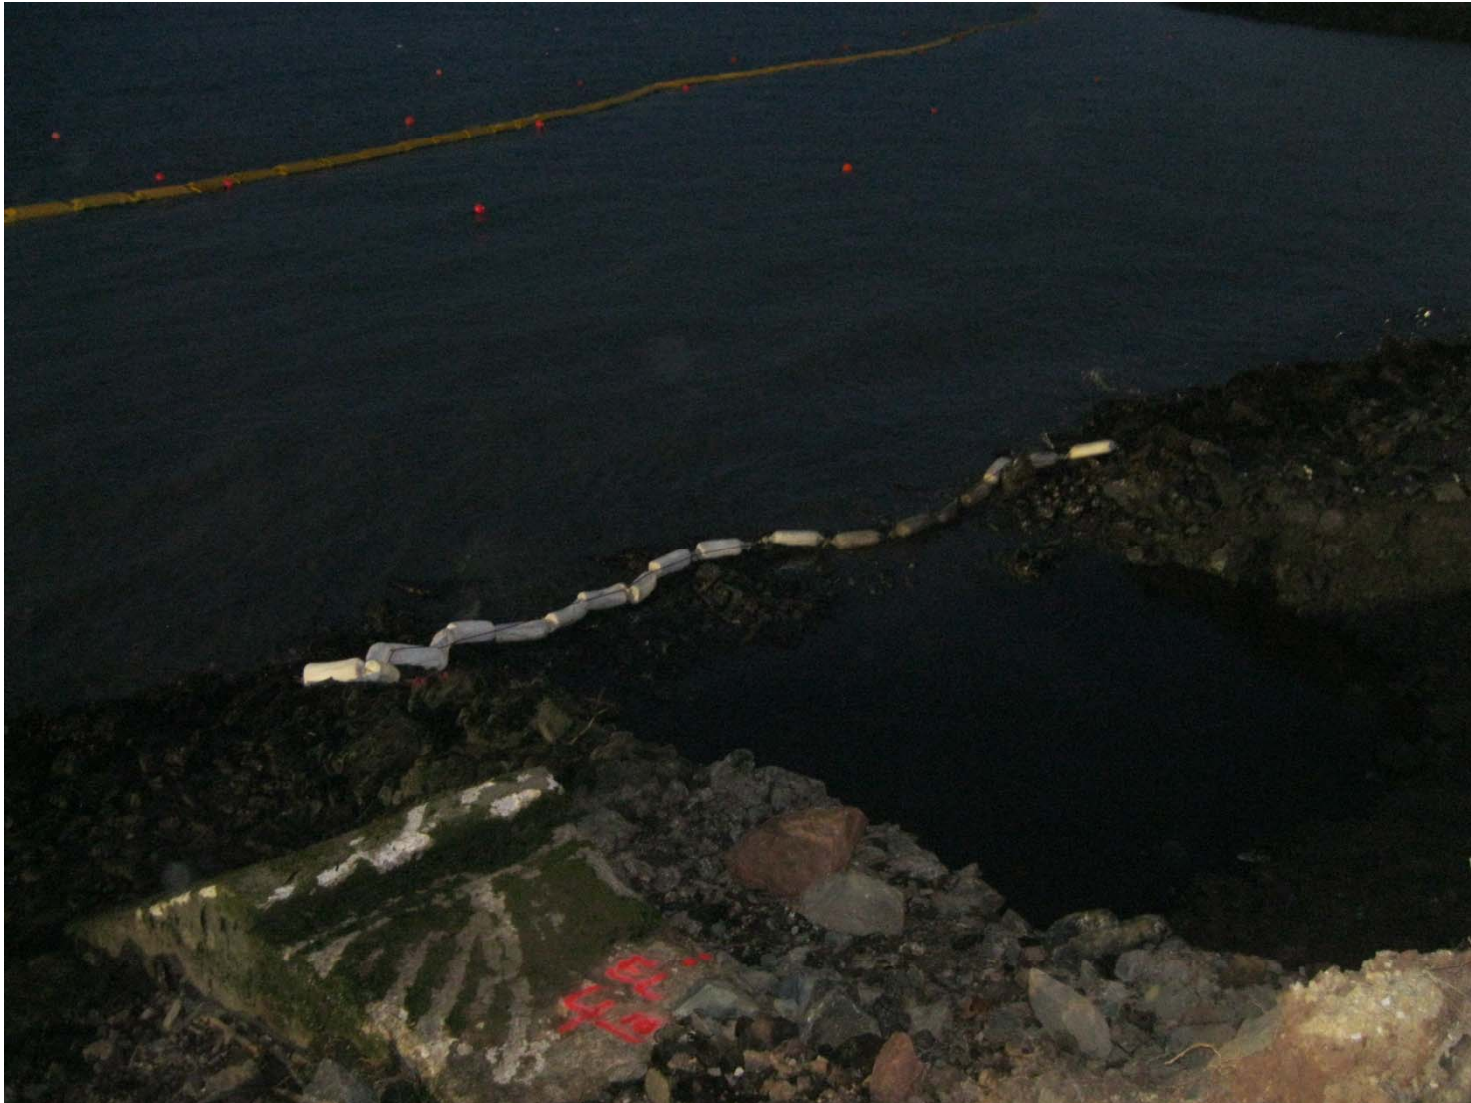
Hydrocarbon-Absorbent Boom Deployed at Toe of Excavation to Prevent Oil Migration to SF Bay

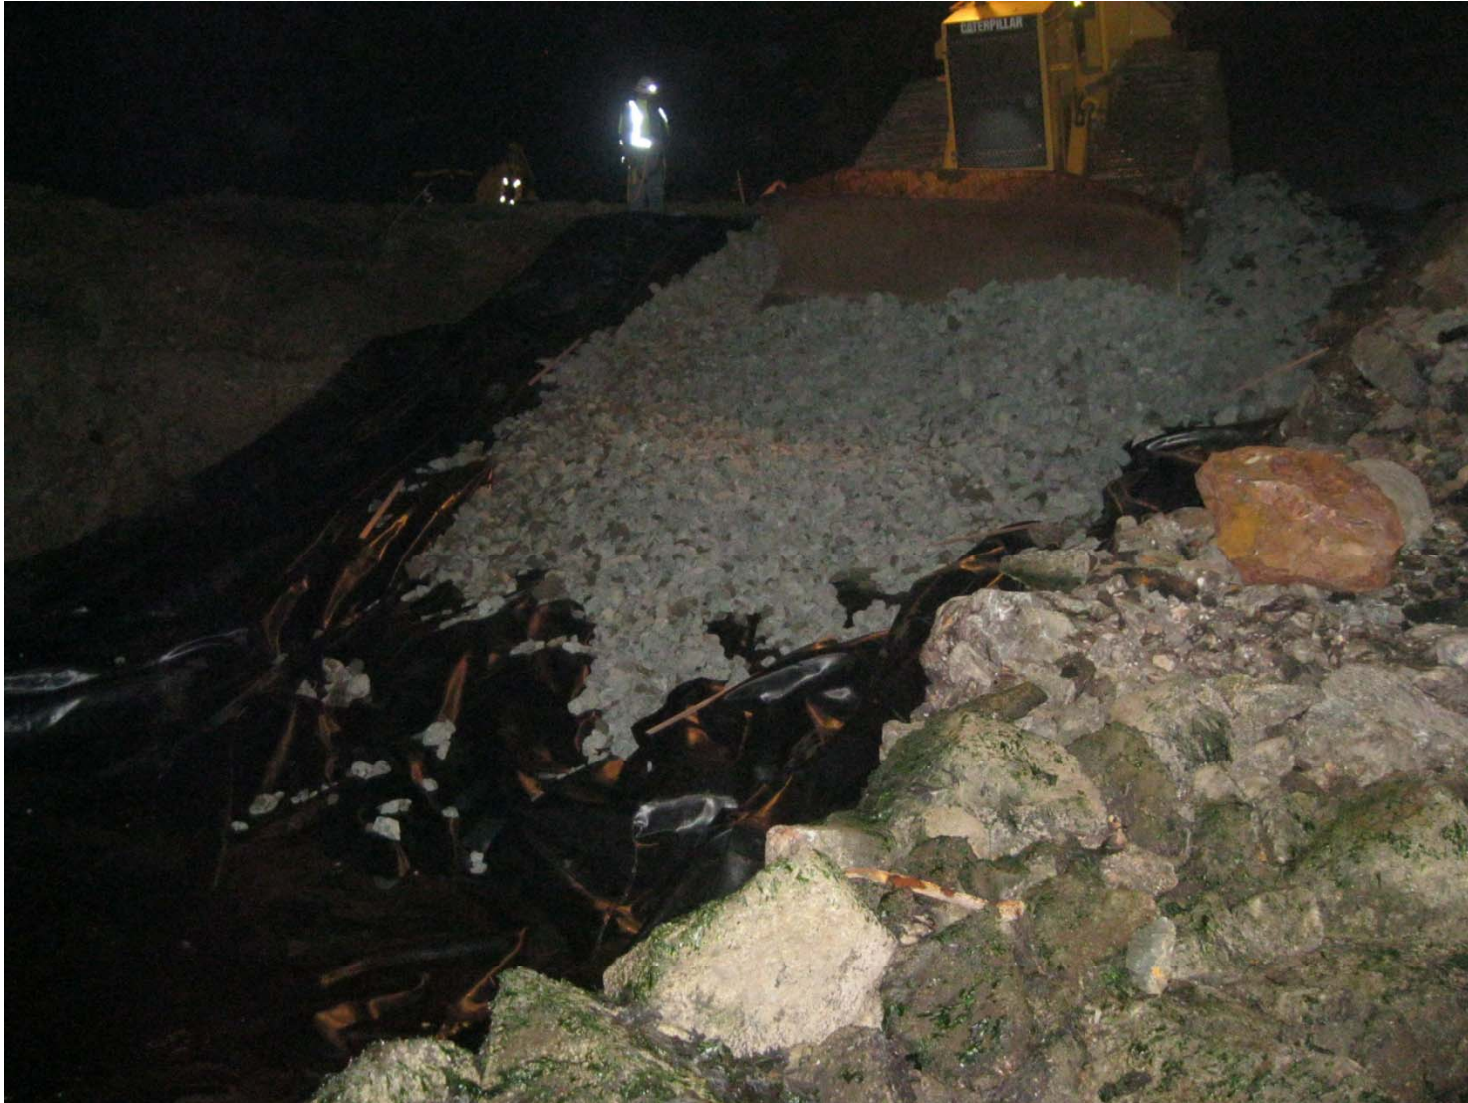
Impermeable Geotextile and Filter Rock Placed Over Excavation to Prevent Sediment Migration

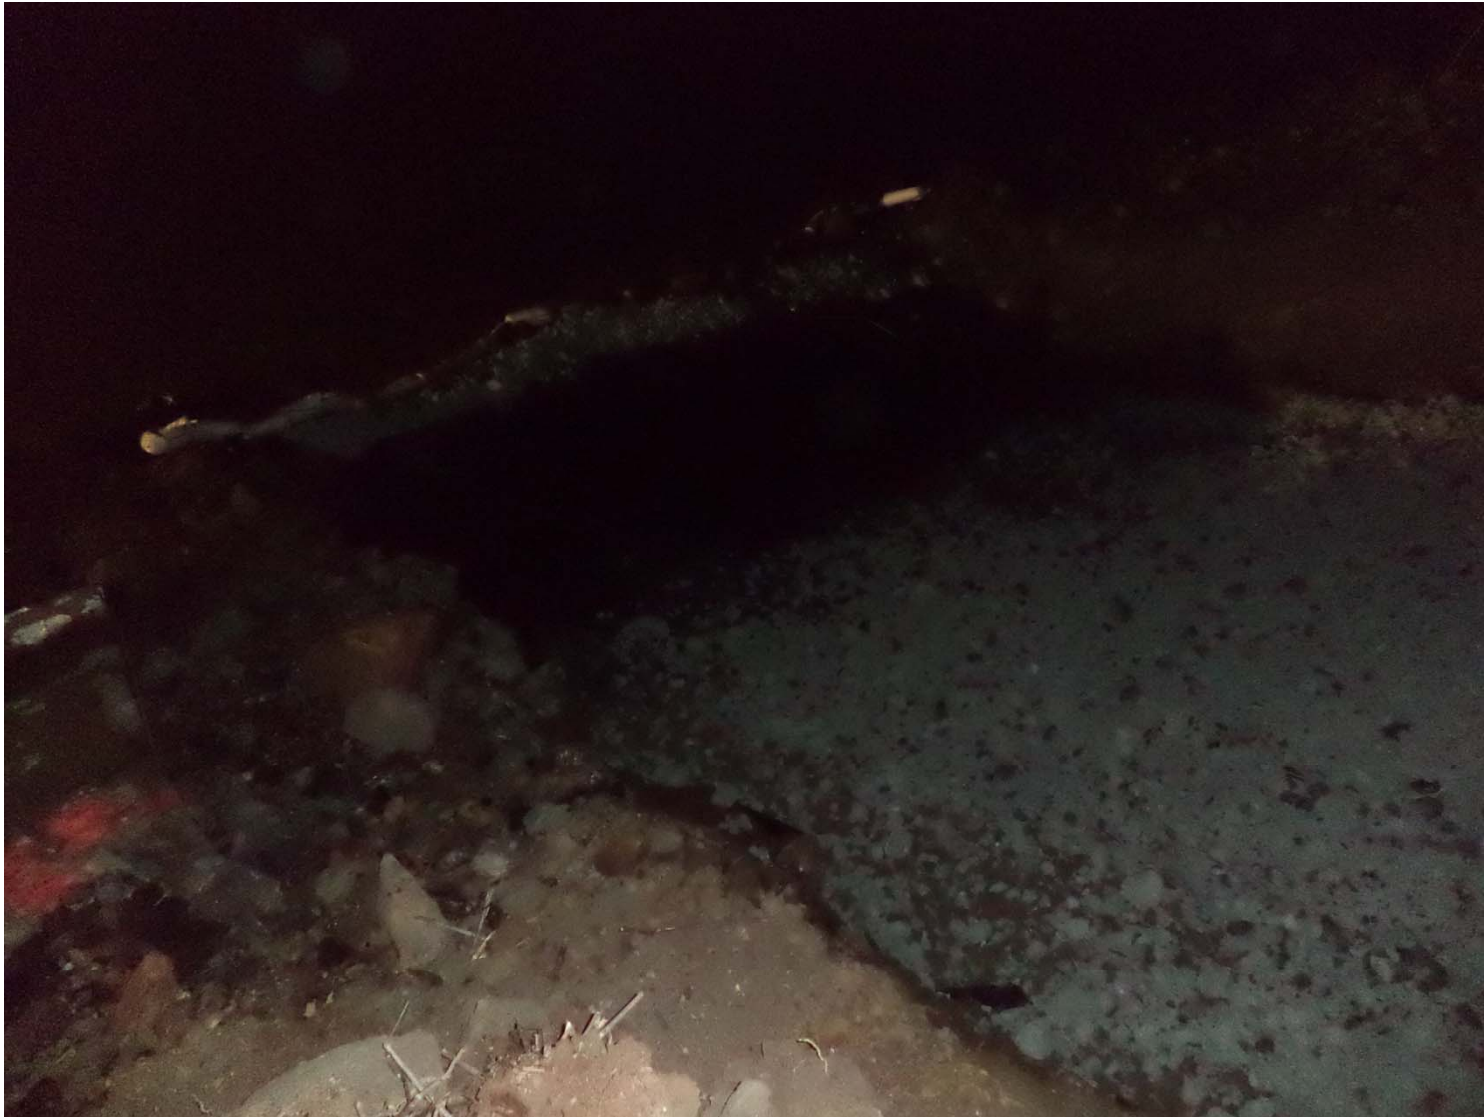
Stabilized Excavation with Hydrocarbon-Absorbent Boom Deployed

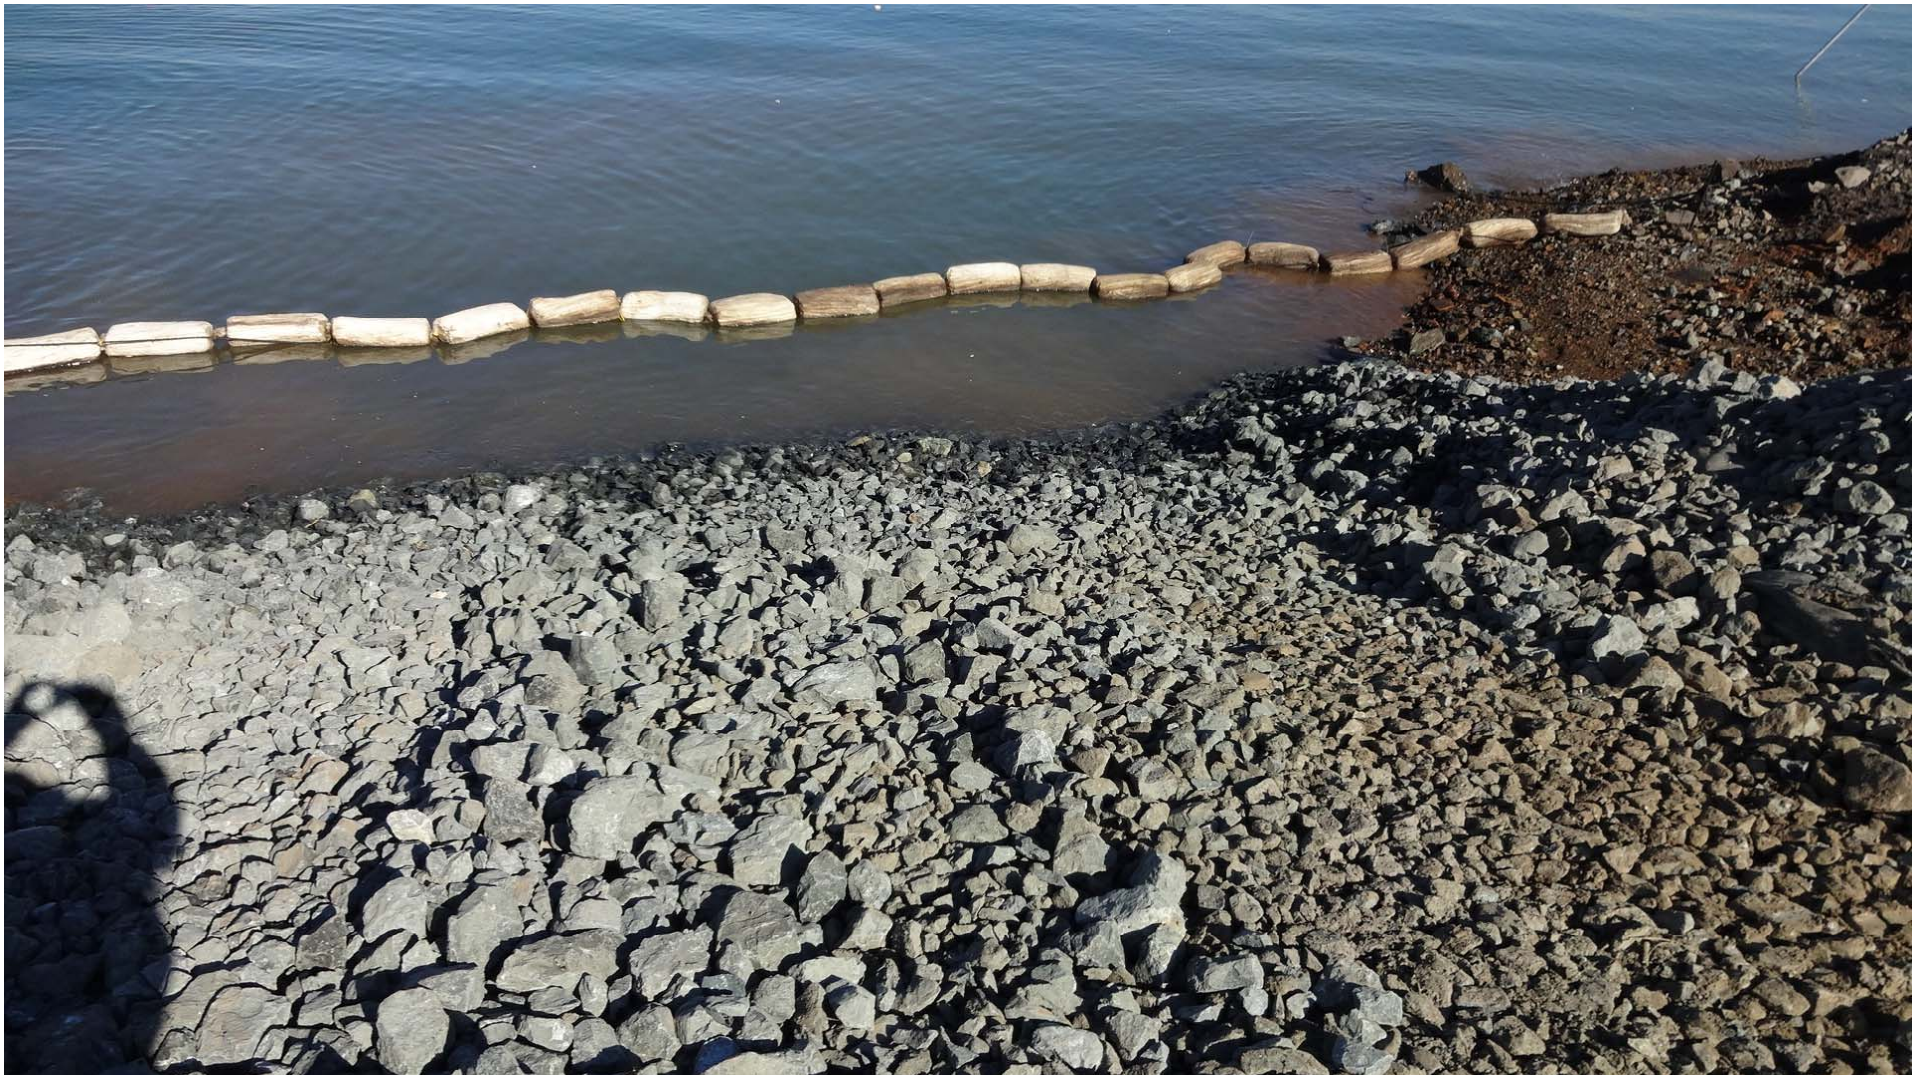
Stabilized Excavation the Next Morning

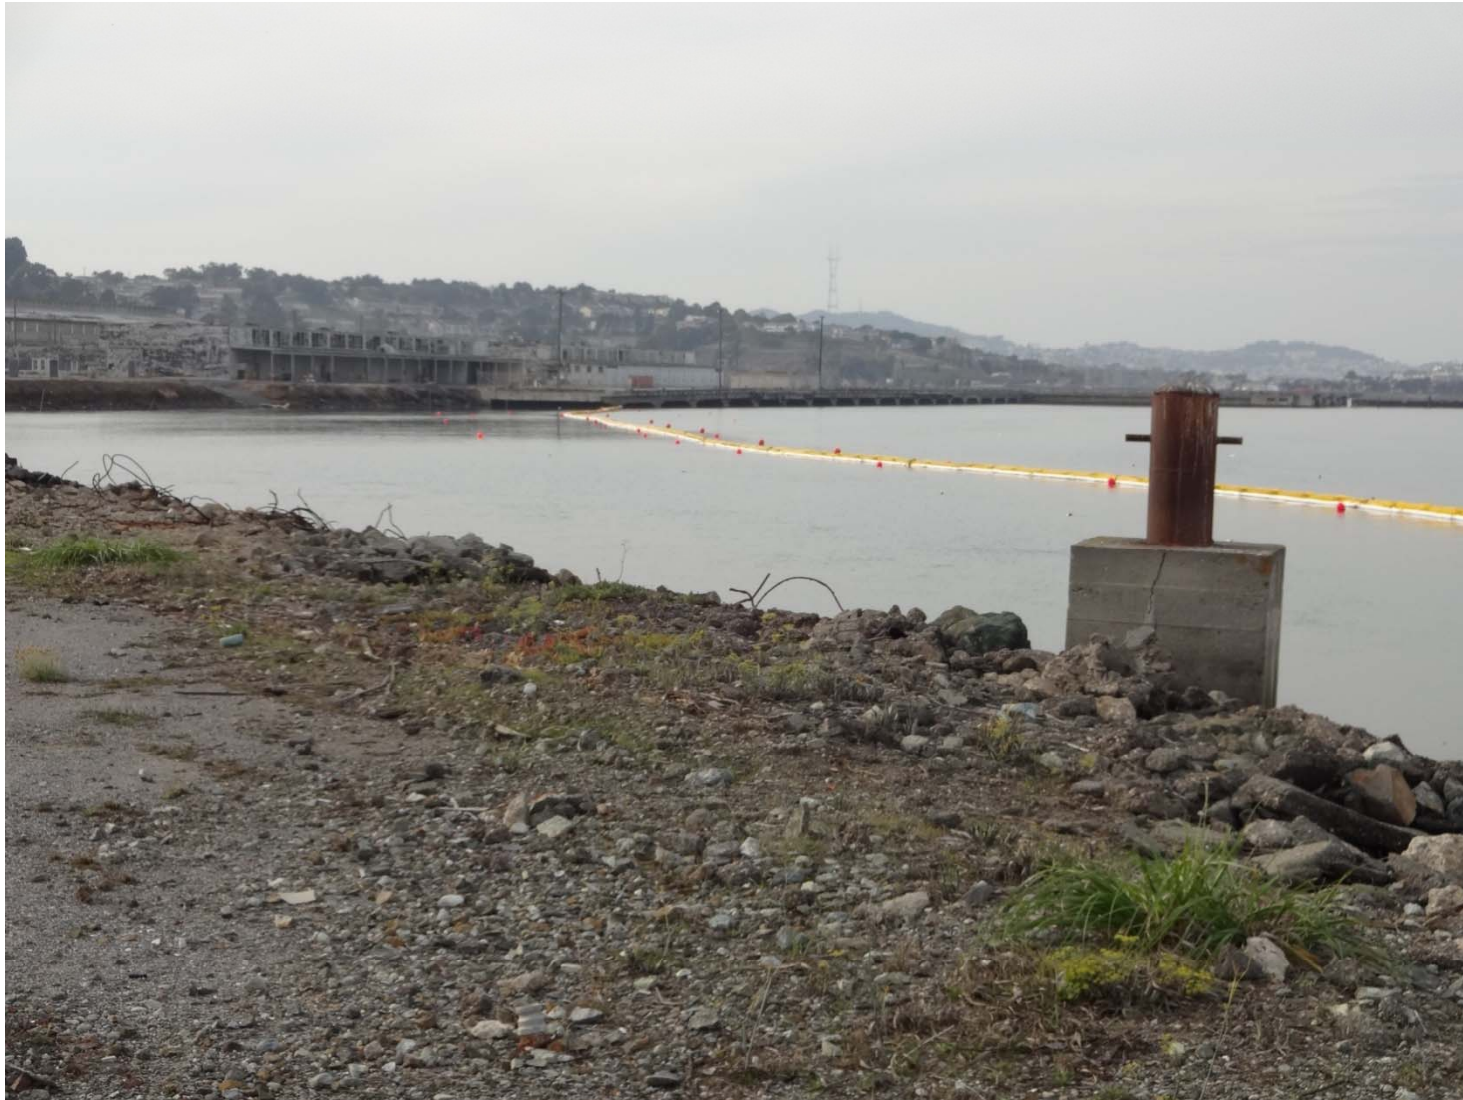
Hydrocarbon-Absorbent Boom Deployed Along Entire Length of Turbidity Curtain

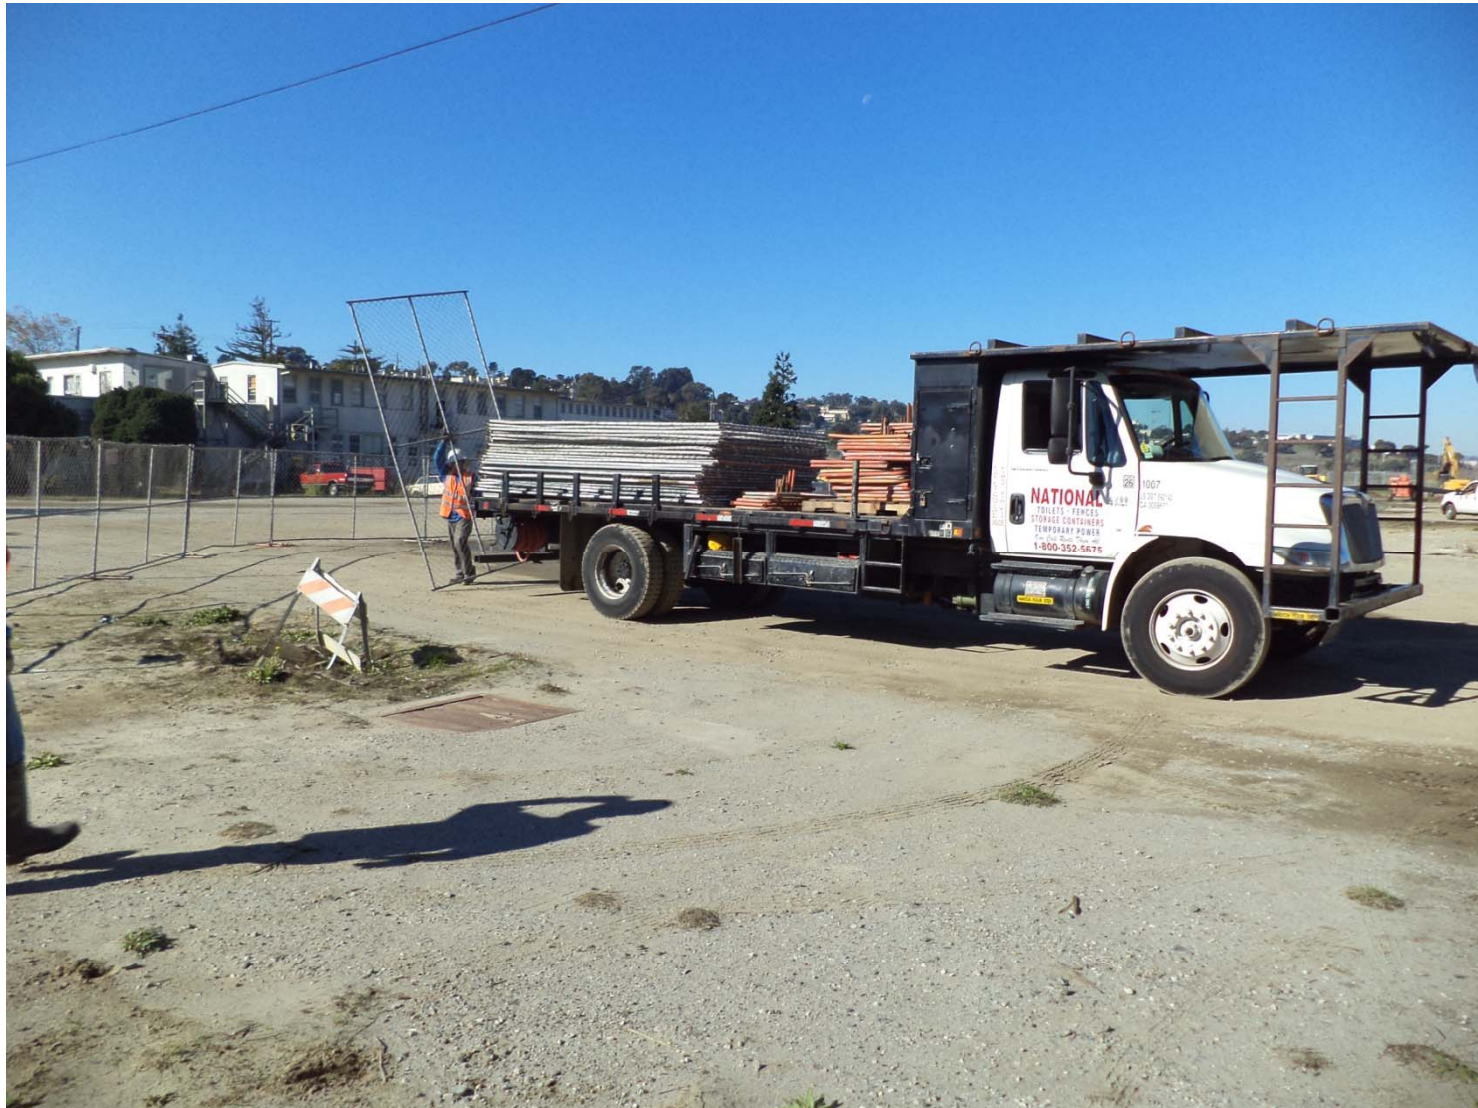
RA Photos Temporary Construction Fence Installed

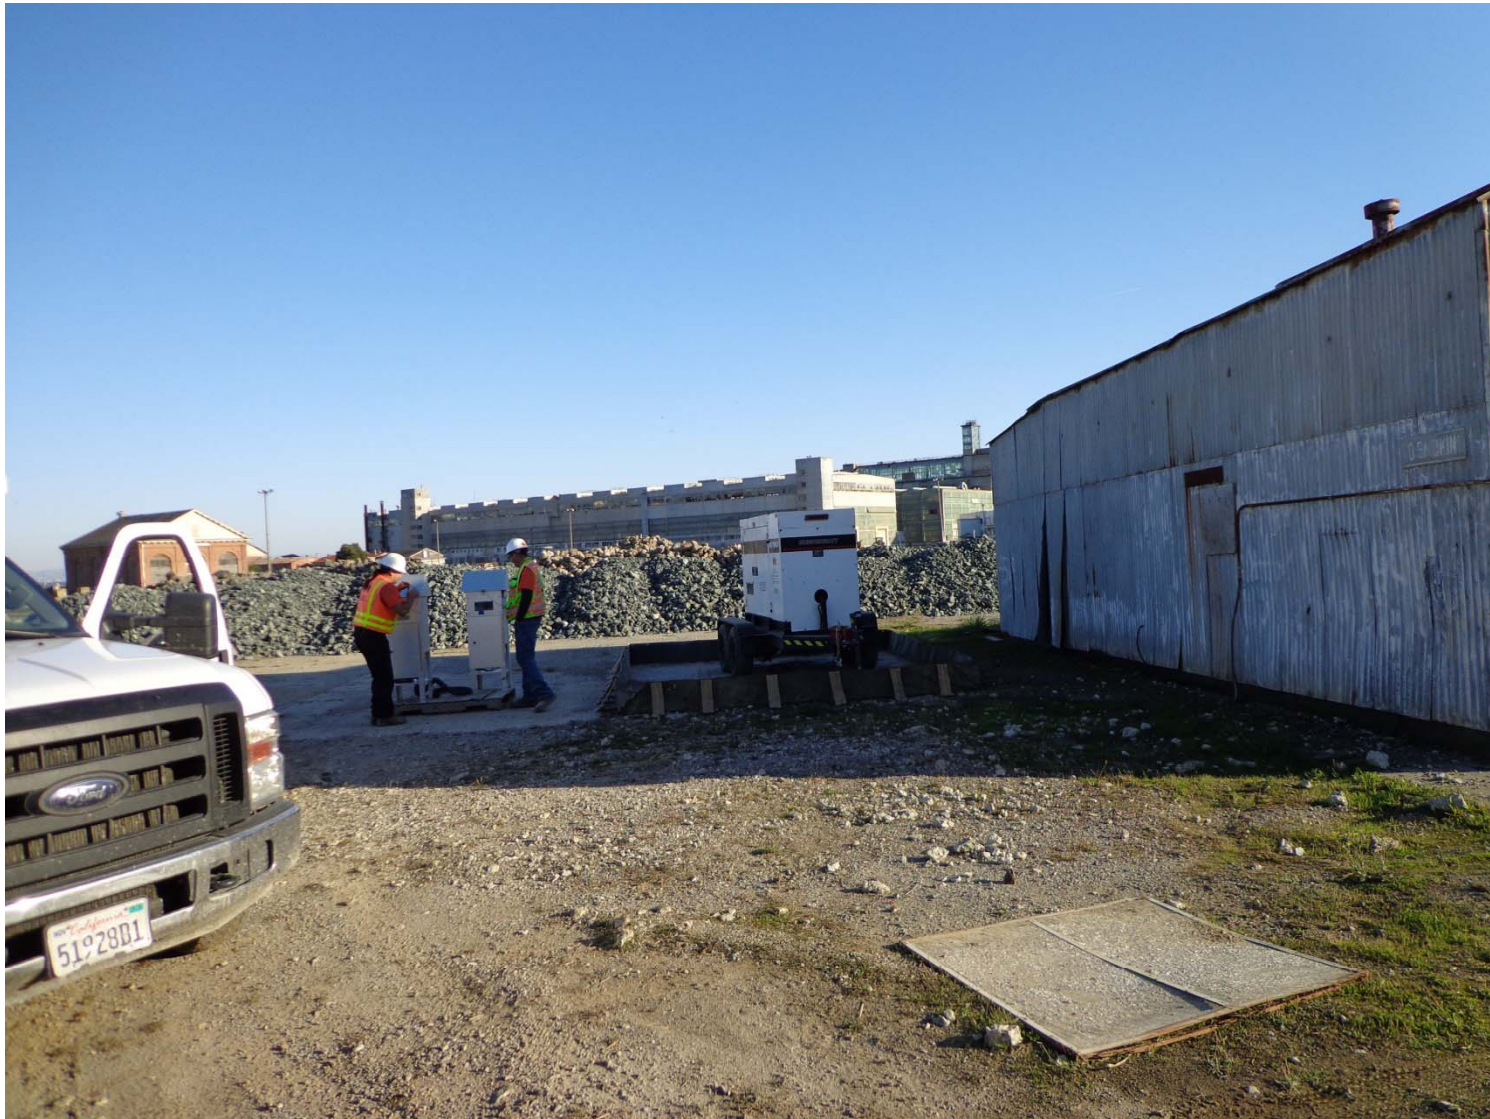
RA Photos High Volume Air Monitoring Stations Set Up

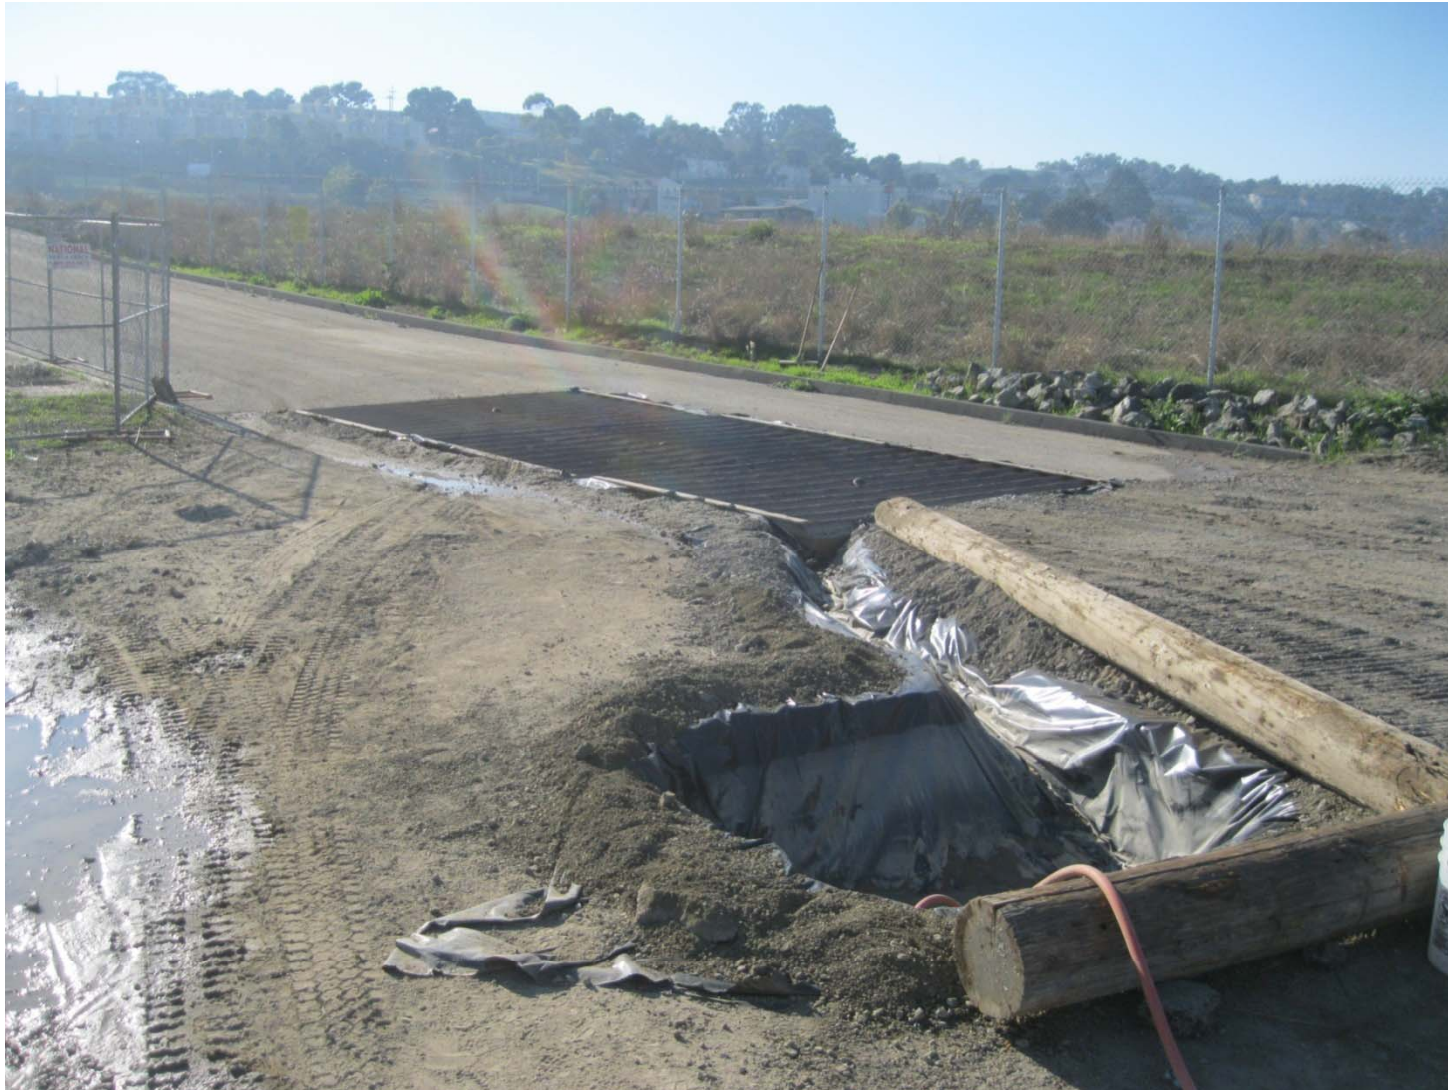
RA Photos Constructing Truck Tire Wash with Recycle System

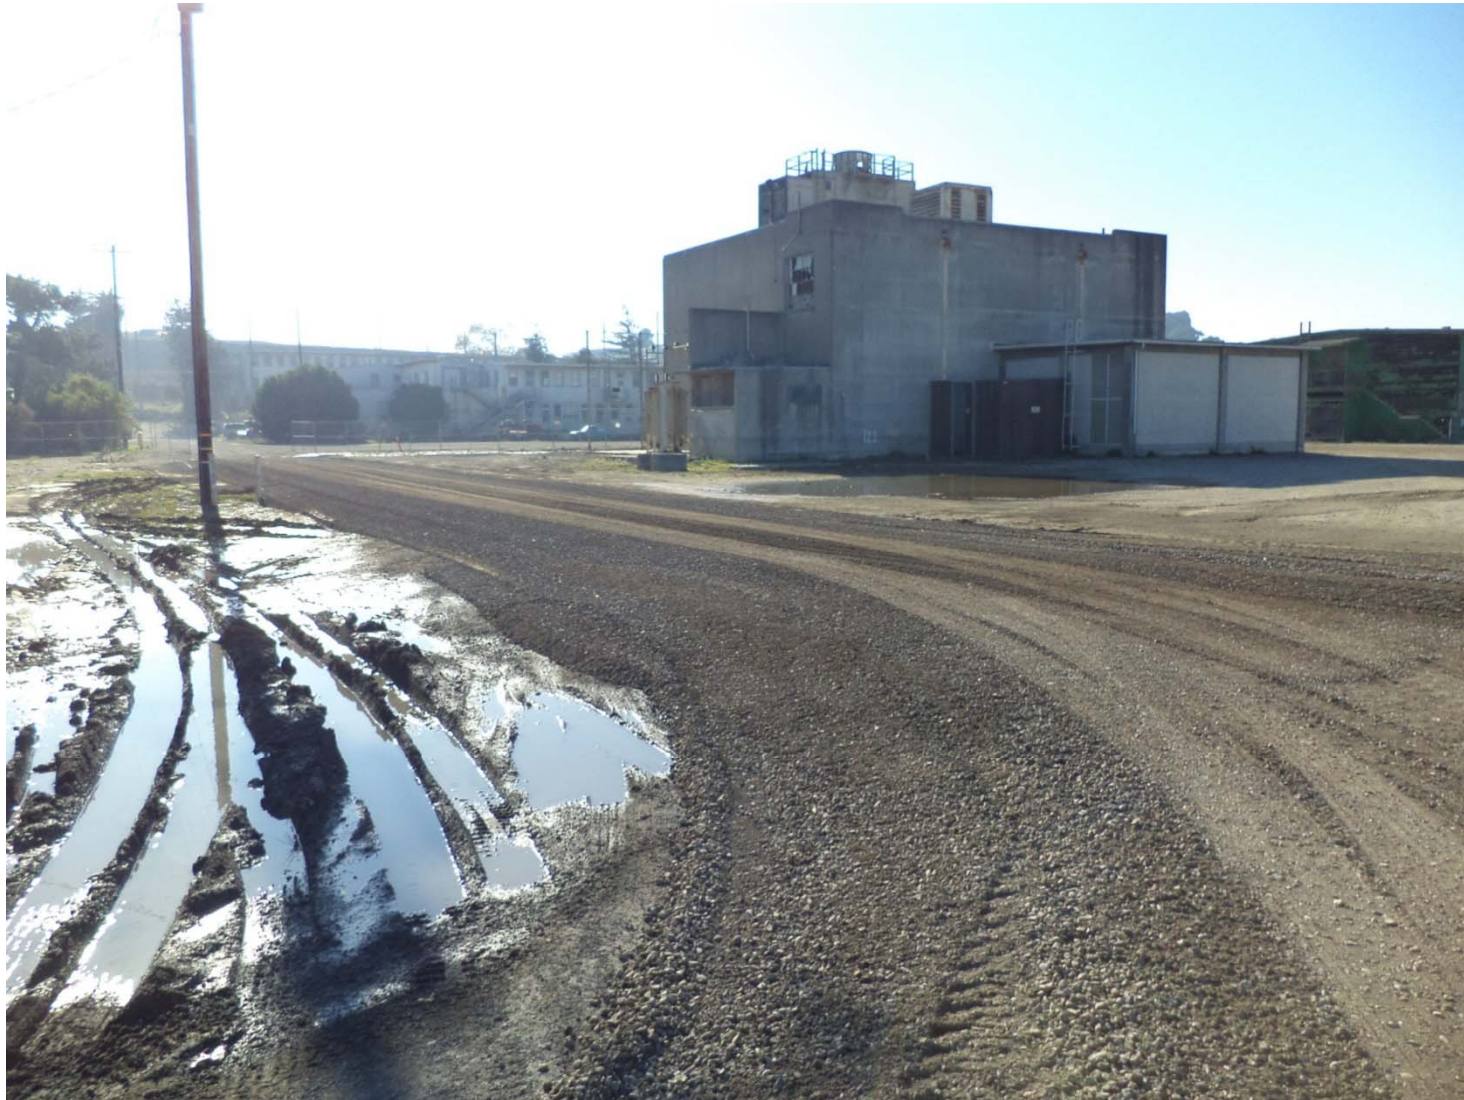
RA Photos Resurfaced Haul Road with AB to Reduce Trackout
